# Manhole Inspection Summary

Manhole # S31QQ\_001MH

**Location** Address: **2434 HUNTINGDON AVE**

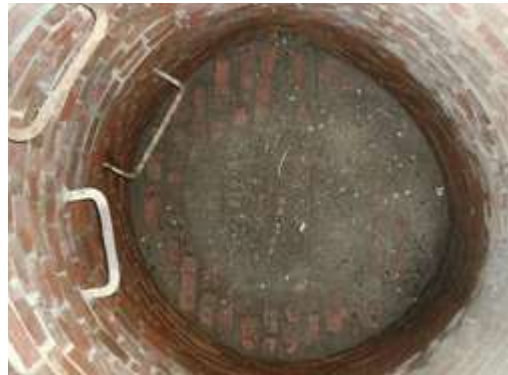
Top View

Channel debris.

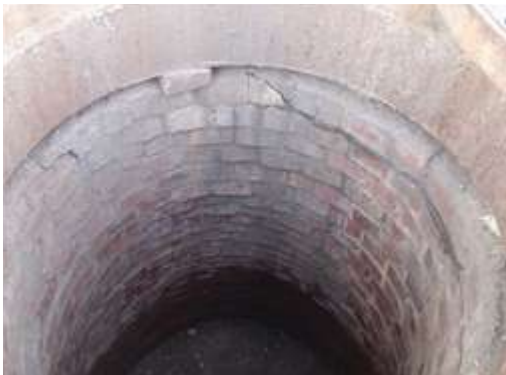
Defect

Frame leaks. Adjustment deterioration, cracks and infiltration. Barrel infiltration - other side.

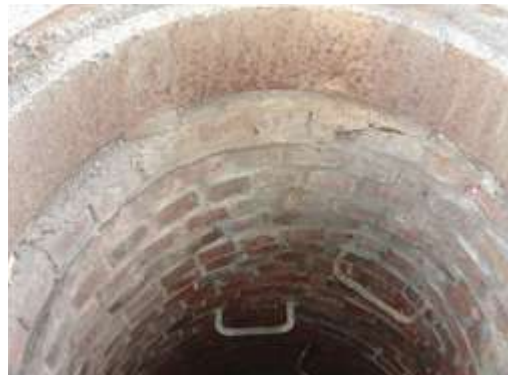
Defect

Frame leaks. Adjustment deterioration and infiltration.

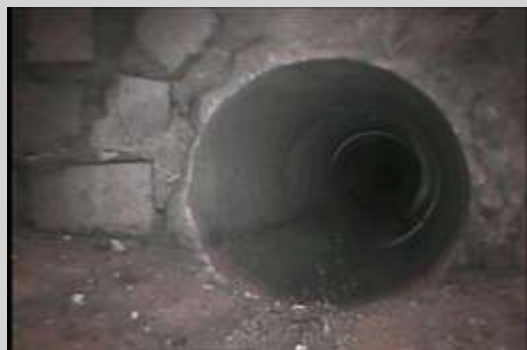
Pipe Out @ 12 O'Clock

Infiltration: **Evidence**

Pipe Seal Cond: **Cracked**
